DEPARTMENT OF TRANSPORTATION

Contract #: 04-0120F4Cty: SF/ALA Rte: 80 PM: 13.2/13.9File #: 69.28**WELDING INSPECTION REPORT****Resident Engineer:**Siegenthaler, Peter**Address:** 333 Burma Road**City:** Oakland, CA 94607**Report No:** WIR-021608**Date Inspected:** 11-Nov-2010**Project Name:** SAS Superstructure**OSM Arrival Time:** 700**Prime Contractor:** American Bridge/Fluor Enterprises, a JV**OSM Departure Time:** 1900**Contractor:** Zhenhua Port Machinery Company, Ltd (ZPMC), Changxing Island **Location:** Shanghai, China**CWI Name:** Xu Le Feng /Qiu Wen**CWI Present:** Yes No**Inspected CWI report:** Yes No N/A**Rod Oven in Use:** Yes No N/A**Electrode to specification:** Yes No N/A**Weld Procedures Followed:** Yes No N/A**Qualified Welders:** Yes No N/A**Verified Joint Fit-up:** Yes No N/A**Approved Drawings:** Yes No N/A**Approved WPS:** Yes No N/A**Delayed / Cancelled:** Yes No N/A**Bridge No:** 34-0006**Component:** OBG Bike Path**Summary of Items Observed:**

WELDING INSPECTION REPORT

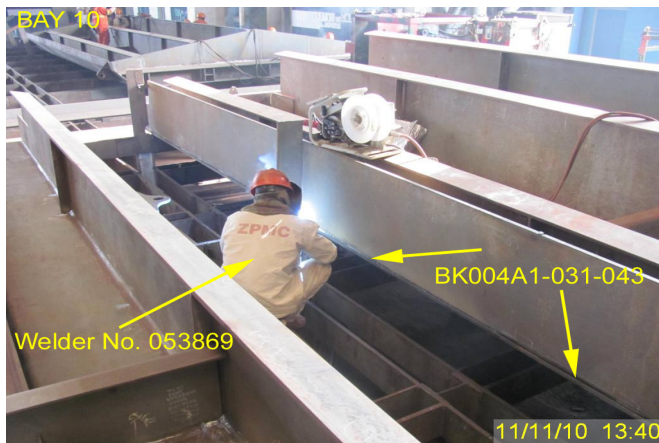
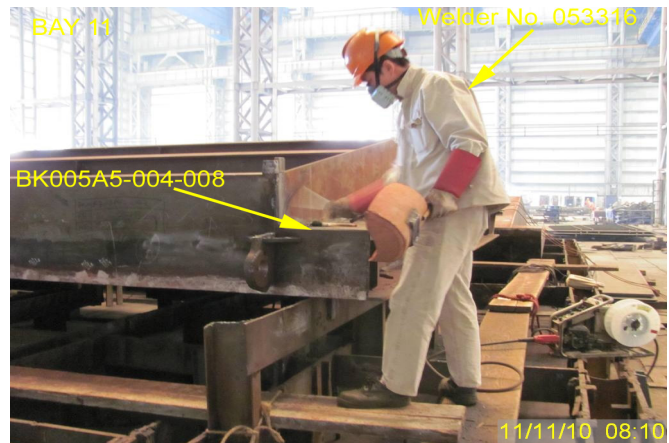
This QA Inspector observed the following work in progress: FCAW welding of weld joint 1,2 located on GGL-MQ-1958-50. Welder is identified as 052075. ZPMC Quality Control (QC) is identified as Qui Wen. The welding variables recorded by QC appeared to comply with the Applicable WPS. See picture for additional information.

This QA Inspector observed the following work in progress: FCAW welding of weld joint 1,2 located on GGL-MQ-1958-47. Welder is identified as 057180. ZPMC Quality Control (QC) is identified as Qui Wen. The welding variables recorded by QC appeared to comply with the Applicable WPS. See picture for additional information.

This QA Inspector observed the following work in progress: FCAW welding of weld joint 072 located on BK004A8-026. Welder is identified as 057238. ZPMC Quality Control (QC) is identified as Qui Wen. The welding variables recorded by QC appeared to comply with the Applicable WPS. See picture for additional information.

This QA Inspector observed the following work in progress: FCAW welding of weld joint 072 located on BK004A6-026. Welder is identified as 040533. ZPMC Quality Control (QC) is identified as Qui Wen. The

welding variables recorded by QC appeared to comply with the Applicable WPS. See picture for additional information.

This QA Inspector observed the following work in progress: FCAW welding of weld joint 043 located on BK004A1-031. Welder is identified as 040302. ZPMC Quality Control (QC) is identified as Qui Wen. The welding variables recorded by QC appeared to comply with the Applicable WPS. See picture for additional information.

This QA Inspector observed the following work in progress: FCAW welding of weld joint 043 located on BK004A1-031. Welder is identified as 053869. ZPMC Quality Control (QC) is identified as Qui Wen. The welding variables recorded by QC appeared to comply with the Applicable WPS. See picture for additional information.

This QA Inspector observed the following work in progress: FCAW welding of weld joint 002 located on BK004A3-034. Welder is identified as 040723. ZPMC Quality Control (QC) is identified as Xu Le Feng. The welding variables recorded by QC appeared to comply with the Applicable WPS. See picture for additional information.

This QA Inspector observed the following work in progress: FCAW welding of weld joint 008 located on BK004A5-034. Welder is identified as 053316. ZPMC Quality Control (QC) is identified as Xu Le Feng. The welding variables recorded by QC appeared to comply with the Applicable WPS. See picture for additional information.
